# **Extensive Metallosis in a Primary Knee** Arthroplasty as a Result of Polyethylene Wear: Is It Avoidable?

## Abstract

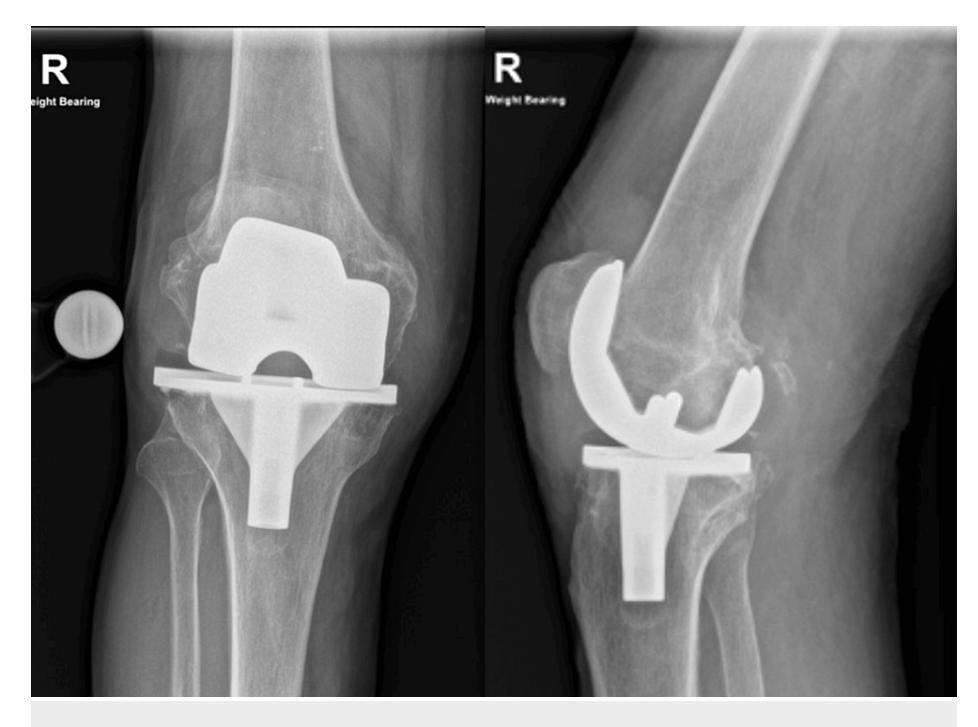
An 85-year-old man, without any comorbidities, who underwent a TKA in 1996, presented to his General Practitioner in 2021 with knee pain and swelling. An X-ray showed PE wear and narrowing of the artificial joint space (Figure 1).

FIGURE 1: Anteroposterior and lateral X-rays of the right knee showing narrowing of the joint space.

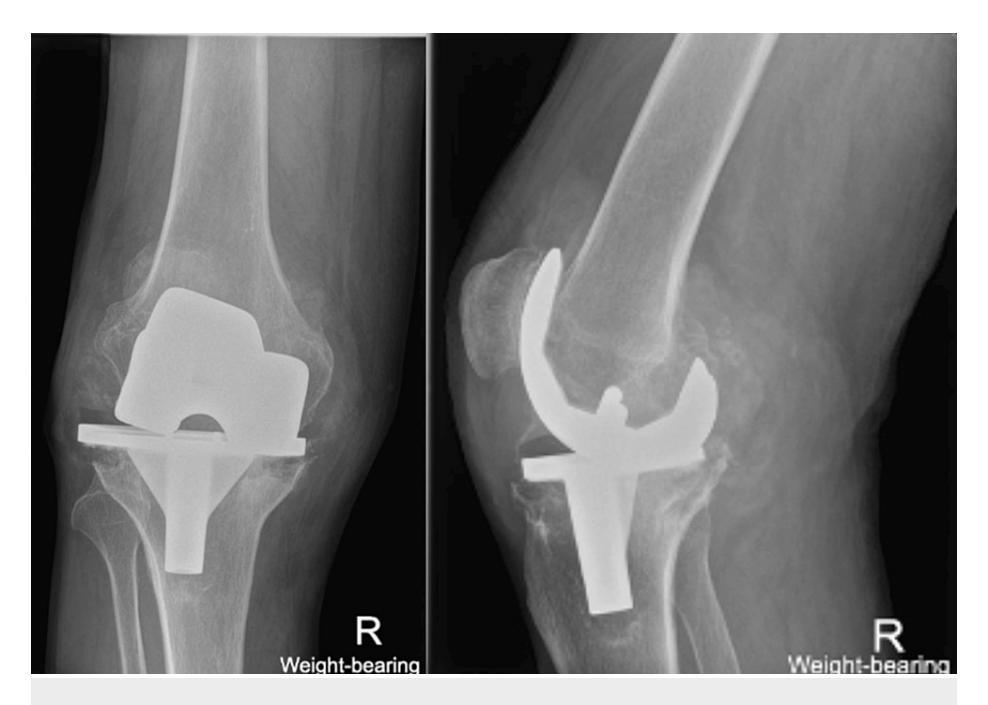
However, due to the COVID-19 pandemic, follow-up and treatment were delayed. Two years later, the patient presented to us with increased knee pain, stiffness, swelling, decreased range of motion (ROM), crepitations, and having to rely on a stick for ambulation. Further imaging showed progressing PE wear, increased loss of joint space, and metal-on-metal articulation of the femoral and tibial components along with osteolysis (Figure 2).

FIGURE 2: Anteroposterior and lateral X-rays of the right knee showing further wear of the polyethylene liner along with osteolysis.

On clinical examination, the patient's knee had a flexion deformity of about 15 degrees with further flexion to 90 degrees and no distal neurovascular deficit. The management plan involved conducting a revision surgery, during which all the implants would be removed from the right knee, followed by radical

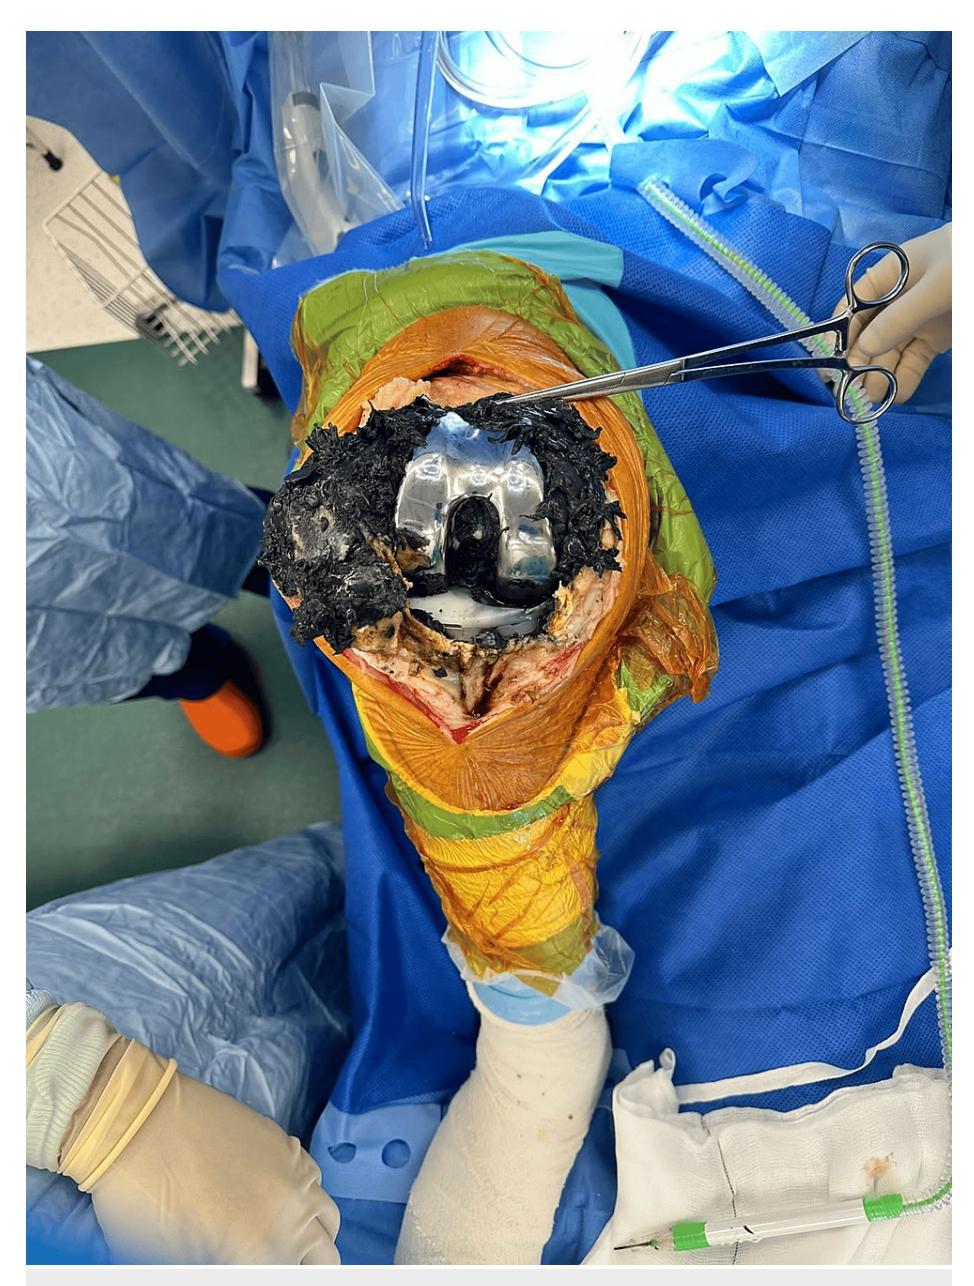
synovectomy of all inflammatory tissue with metallic debris deposits if present, and, finally, implanting a prosthesis with a level of constraint depending on the knee's ligamentous integrity. During the surgery, extensive metallosis with dark black-stained synovial tissue was seen due to the deposition of metal debris in the surrounding tissue (Figure 3).

FIGURE 3: Metallosis within the surrounding tissue.

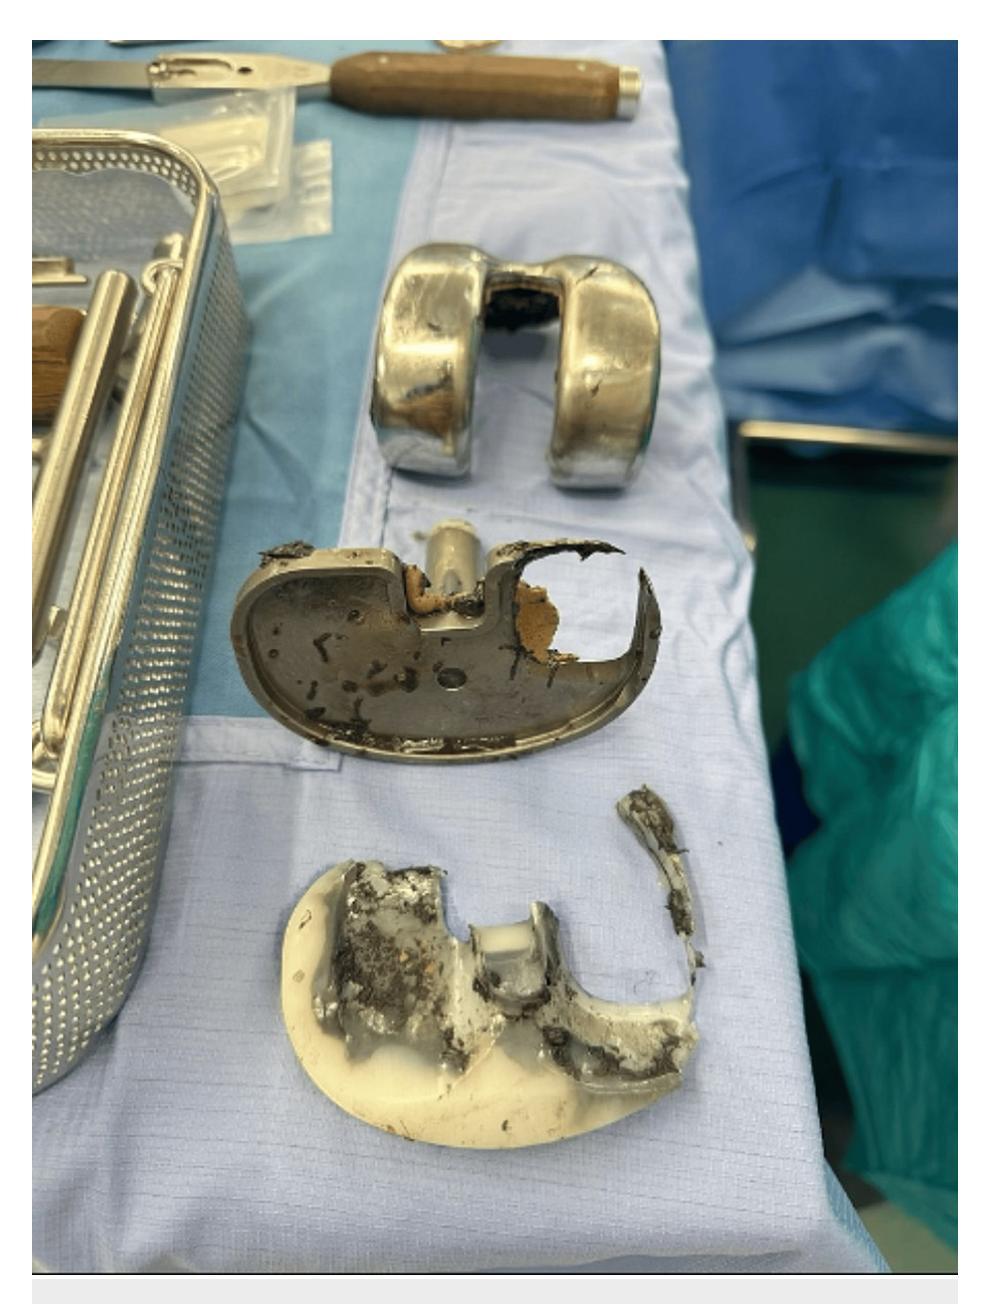
FIGURE 4: Knee prostheses of the right knee showing polyethylene wear with tibial tray defect.

After extensive debridement of stained tissue, the prosthetic components were removed (Figure 4), the knee was washed out, and a new semi-constrained modular revision knee prosthesis (Attune revision system, Depuy) was implanted (Figure 5) using sleeves and cones to achieve good fixation. The extracted prosthesis was a PFC (Press Fit Condylar, Depuy) Sigma fixed bearing, in which the femoral component was made of cobalt-chromium and the tibial tray was made of titanium with a matte articulating surface. The extracted insert was deficient posteromedially and resulted in a large defect in the corresponding area of the tibial tray (Figure 6). Because of bone loss and poor metaphysis, the sleeves and long stems were used on both the femoral and tibial sides. The patient had an uneventful postoperative recovery and was allowed to fully weight-bear. At his six-week follow-up, the scar had healed well and he was walking without any support with an ROM of 0 to 100 degrees.

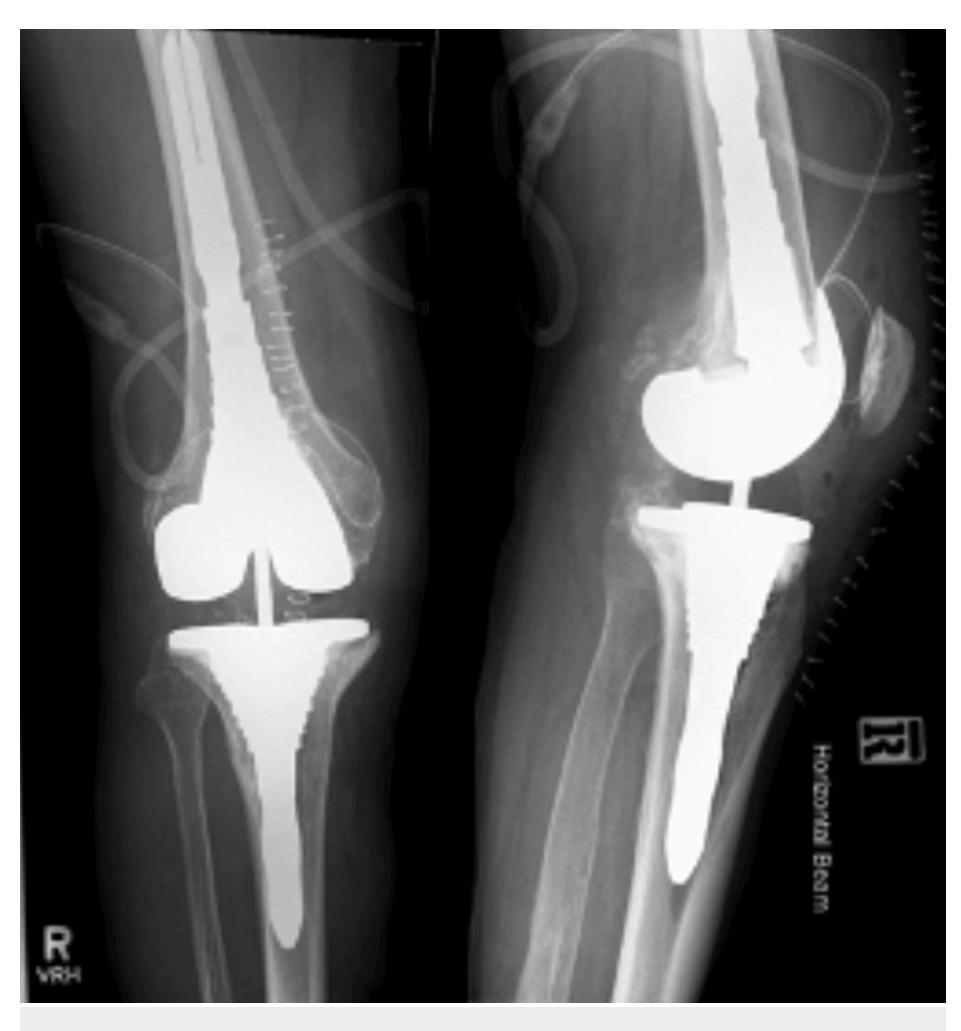
FIGURE 5: Postoperative anteroposterior and lateral X-rays.

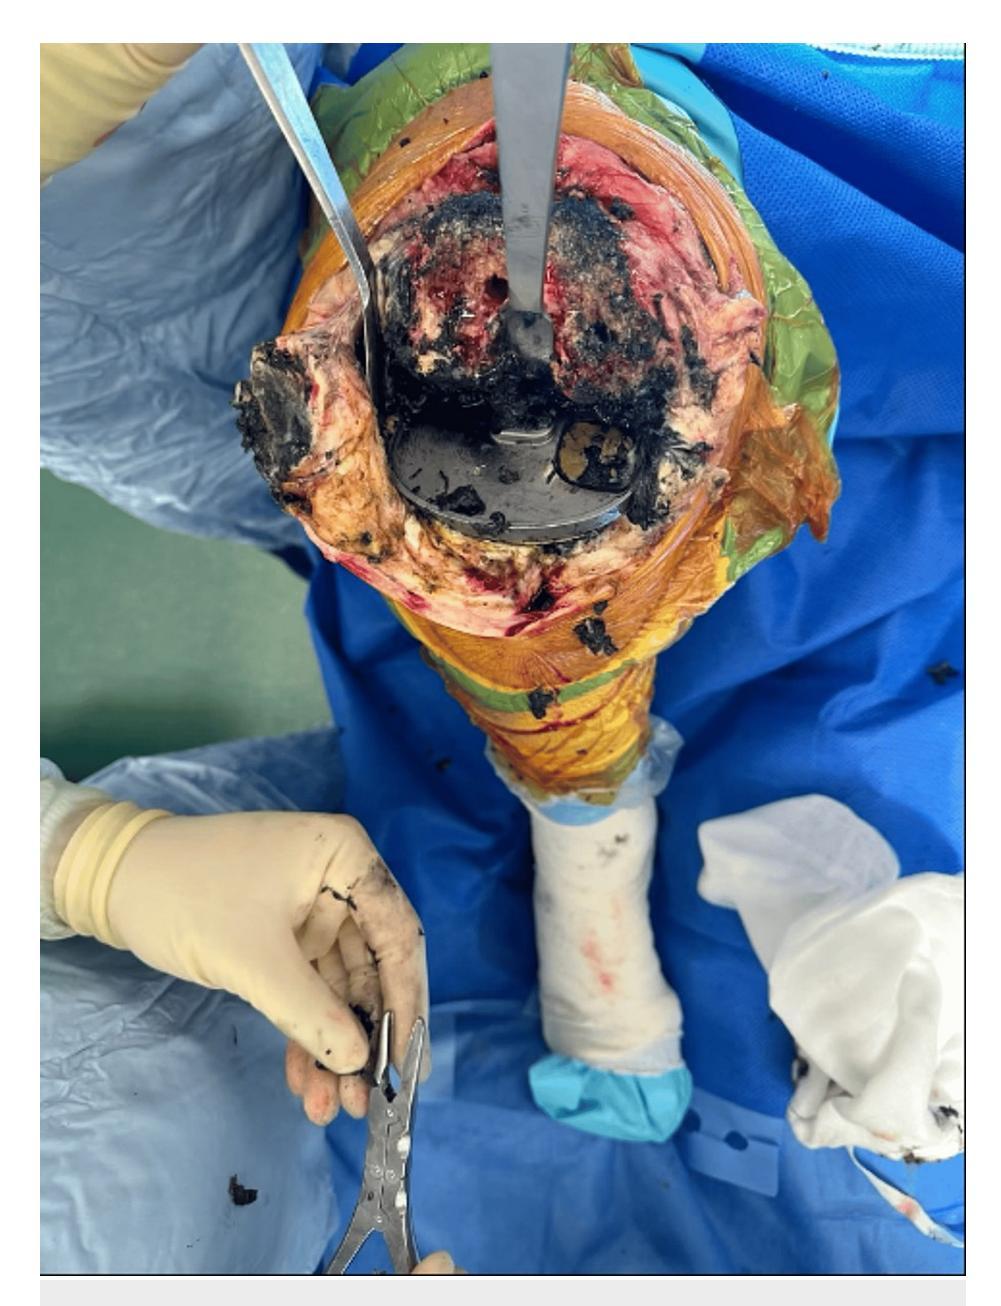
FIGURE 6: Tibial tray defect posteromedially.
