An investigation of oil leakage from automotive driveshaft radial lip seals

Petros Nomikos^{1,2}, Ramin Rahmani¹ , Nicholas Morris¹
and Homer Rahnejat^{1,3}

Proc IMechE Part D:
J Automobile Engineering
1–17

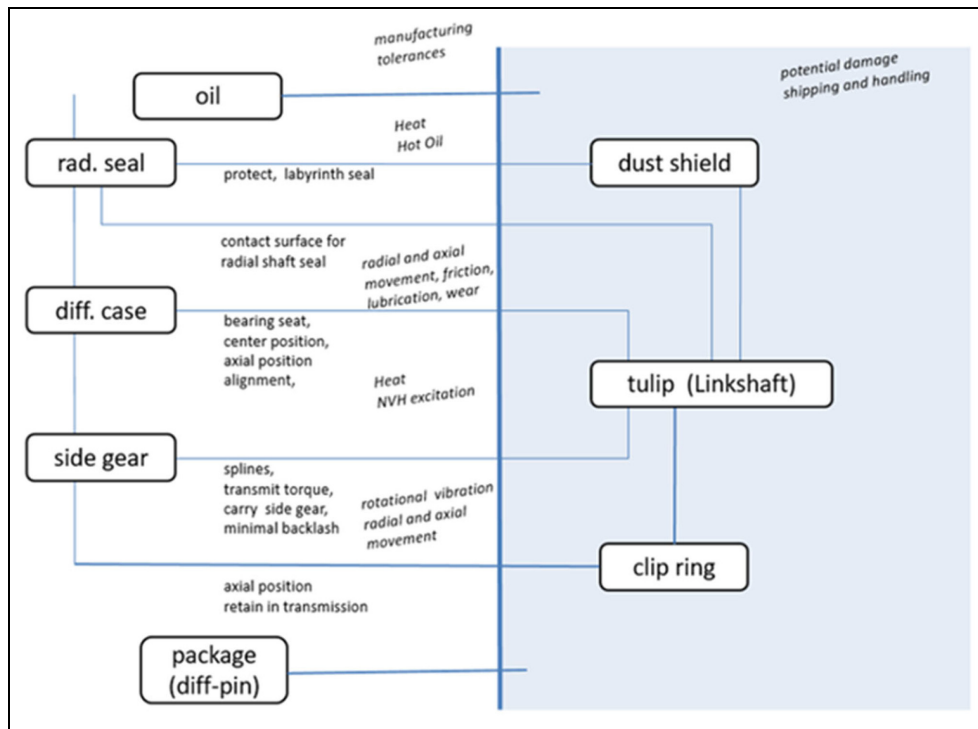
Figure 1. Influential factors in a vehicular transmission sealing system.

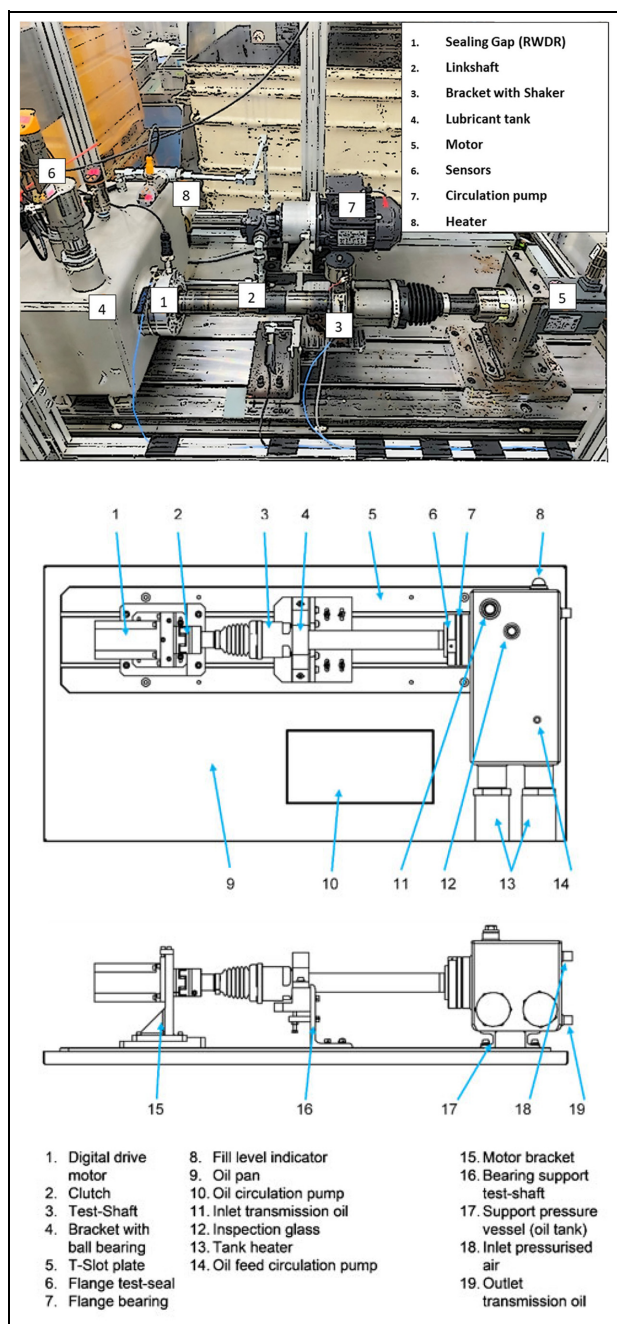
Figure 2 presents a schematic of the developed test-rig. The radial shaft seal test specimen resides in the flange (6) of a sump of lubricant, which represents the transmission housing. It forms the sealing system in combination with the sealing seat of the driveshaft (3). The shaft is driven by an electric motor (1), which generates the desired representative operating conditions of a vehicular gearbox. The driveshaft is supported by a bearing, mounted on the original bracket (16). The clutch (2) of the drive motor and the seat of the journal-bearing (7) are all positioned in the tank of lubricant. The sump is filled with the transmission fluid to any desired level. The sump is equipped with a heating element to bring the transmission fluid to the desired representative operating temperature. To record the

Figure 2. The developed test-rig and its schematic representation.

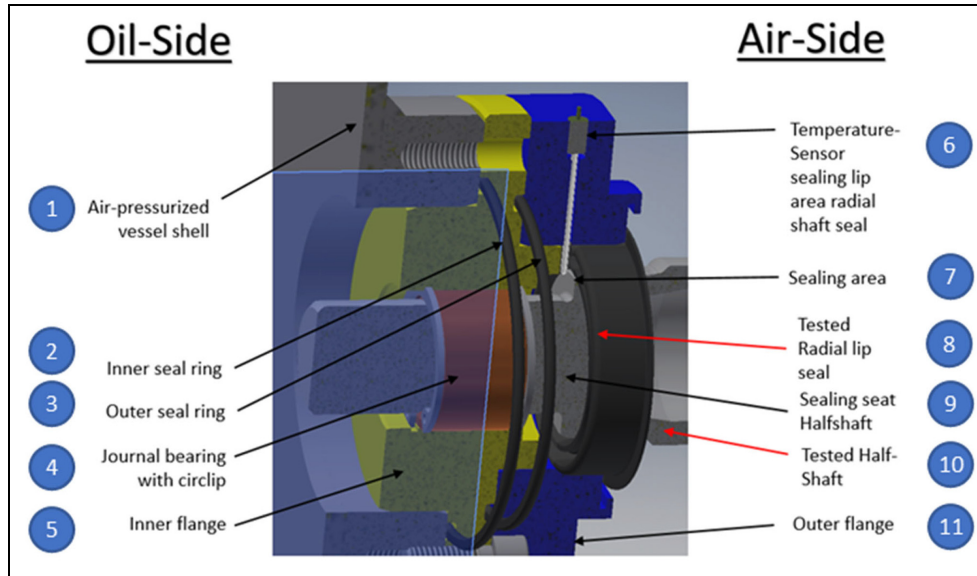
The sealing system in Figure 3 is at the core of the test-rig. The sealing flange has a comparatively simple structure, the main components of which are its inner and outer flanges (5), (11). The sealing flange is mounted in the sump (1) and can easily be replaced when the application or the technical requirements change. In principle, the main task for the inner and the outer seal rings (2), (3) is to isolate the flanges from

Figure 3. Inner structure of the sealing-flange.

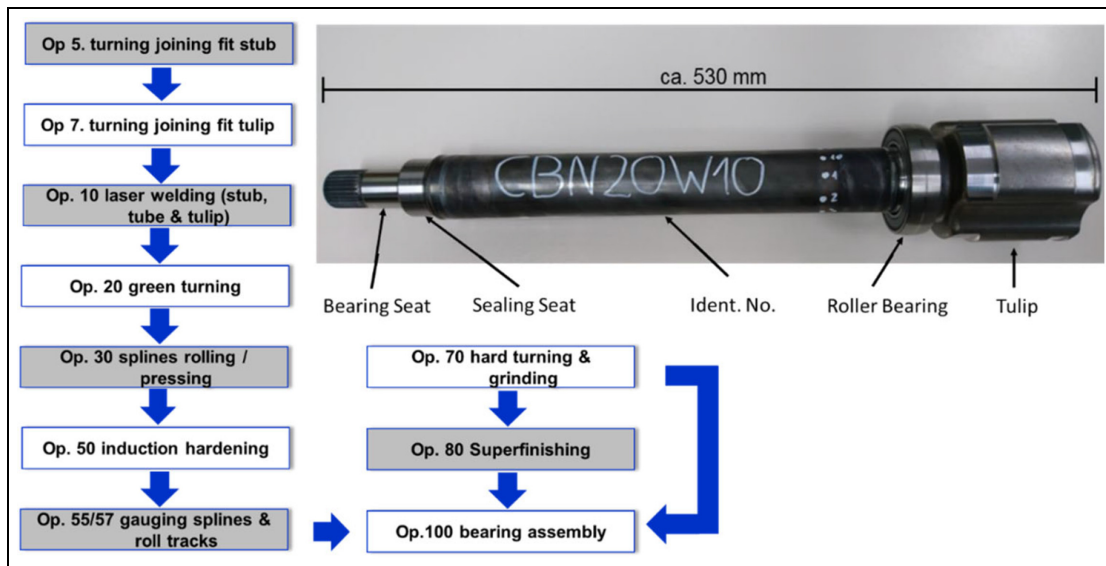
Figure 4. An example of CBN-ground link-shaft.

In the current study the leakage behaviour of link-shafts is considered of primary concern. Such shafts are inboard-joints which transfer the force from the differential to the wheel-hub in cases that the vehicle engine is not centrally located. Through the elongation of an inner joint an appropriate movement can be accommodated. An example of a link-shaft to be tested for its leakage performance is shown in Figure 4. The sequential manufacturing process is also illustrated by the flow-chart in the same figure.

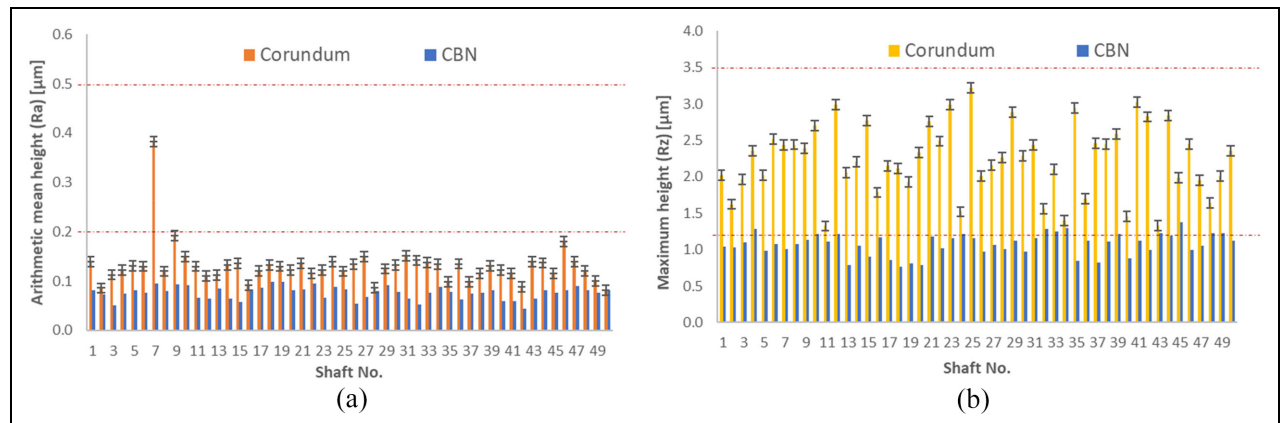
**Figure 5.** Measured (a) Ra and (b) Rz.

The measured surface quality of the shaft sealing seats for R_a and R_z can be obtained, using Figure 5(a) and (b). In Figure 5, all the measured R_a values are given within the tolerance range for corundum and

CBN grinding in the industrial standards such as DIN 8589-14.³⁶ Approximately, the same condition applies for the R_z values measured for the tested shaft specimens in Figure 5(b). It is clear that the tolerance range for R_z is utilised to a greater extent, but still within the desired range. Several measured values can be found at the upper tolerance limit. Additionally, it is noticeable that there is a greater spread of values for R_z . Thus, overall, both manufacturing processes fulfil the required surface specifications set by the appropriate standards. It can also be seen that in comparison to the

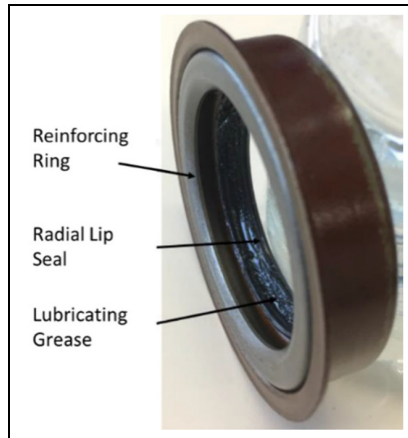
Figure 6. Radial lip seal ANIS-I 177-I 543 933.

An example of radial shaft seals used during the experiments is shown in Figure 6. This type of seal is coated before the test-runs with a sealing paste pressed onto the test flange of the rig. This action is essential in order to ensure that no lubricant can ingress in between the outer diameter of the rotary shaft seal and the inner diameter of the test flange. The rotary shaft seal is equipped with a reinforcing ring, containing an elastomeric sealing material. Each sealing ring is greased to prevent a dry run-in start-up or stop conditions. For

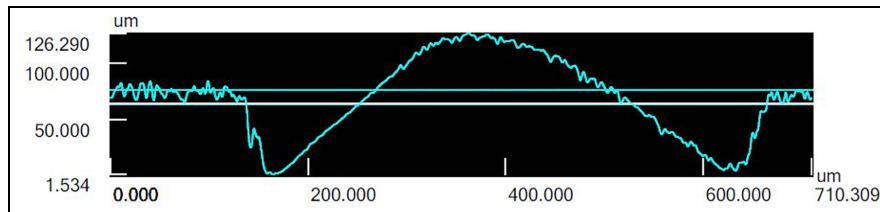
Figure 7. Measured lip seal profile.

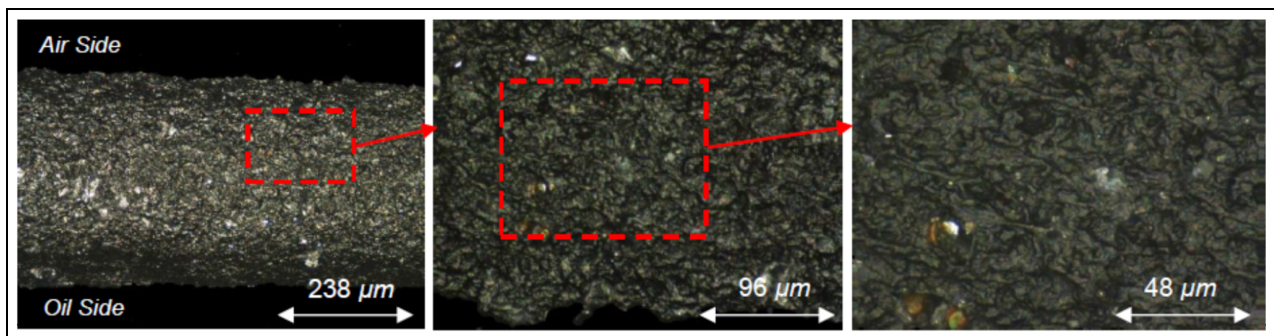
Figure 8. Topographical surface features of the lip seal under $20\times$, $50\times$ and $100\times$ optical magnifications.

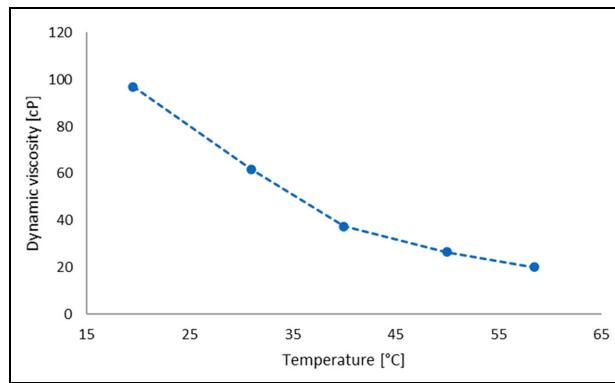
Figure 9. Measured dynamic viscosity of Titan Sintofluid FE SAE 75 W at different temperatures.

in the actual transmission of the test vehicle (simulated with the developed test-rig). The lubricant dynamic viscosity variation with temperature is shown in Figure 9. For this purpose, a U-tube viscometer was employed. To measure viscosity at different temperatures the U-tube viscometer was submerged into the tank of fluid containing an electrical heating element. After the tank temperature reaches a prescribed steady-state level, the time taken for the lubricant to flow within the U-tube viscometer between two fixed points is measured. This procedure was repeated five times at each temperature and the average value were noted. The kinematic viscosity of the lubricant was obtained based on multiplying the time taken in seconds to the viscometer constant. To measure the density of the lubricant at each temperature, the heated lubricant was poured into a 15 cm³ volumetric flask and its mass was measured.

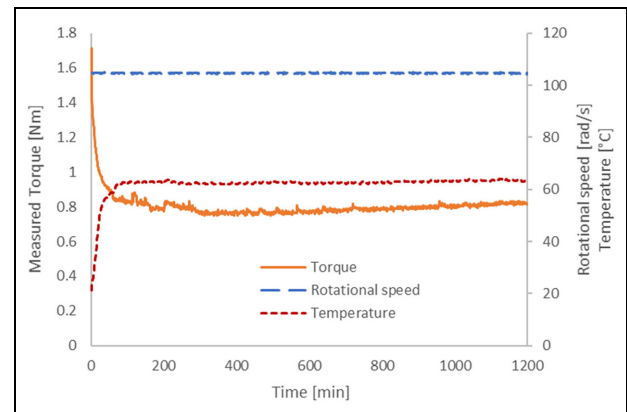
Figure 10. An example of monitored torque, speed and temperature variation during the tests.

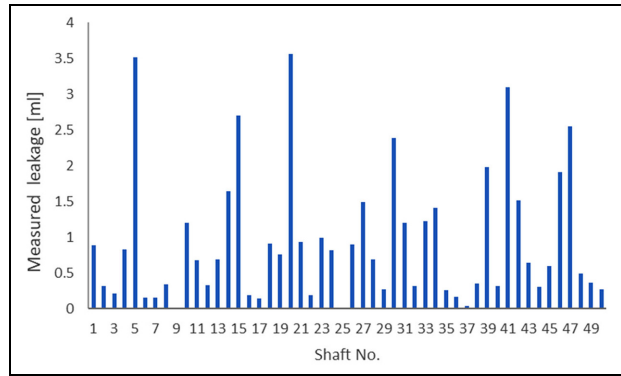
The measured leakage value for each tested corundum ground link-shaft is shown in Figure 11. It is also observed that most leakage occurs during the initial break-in period, after which the leakage rate is significantly reduced. However, because the monitoring of leakage was not automated, all the shafts were exposed to a 20-h period of break-in process in order to ensure that all shaft surfaces have reached their break-in points.

Figure 11. Measured leakage from all corundum ground shafts.

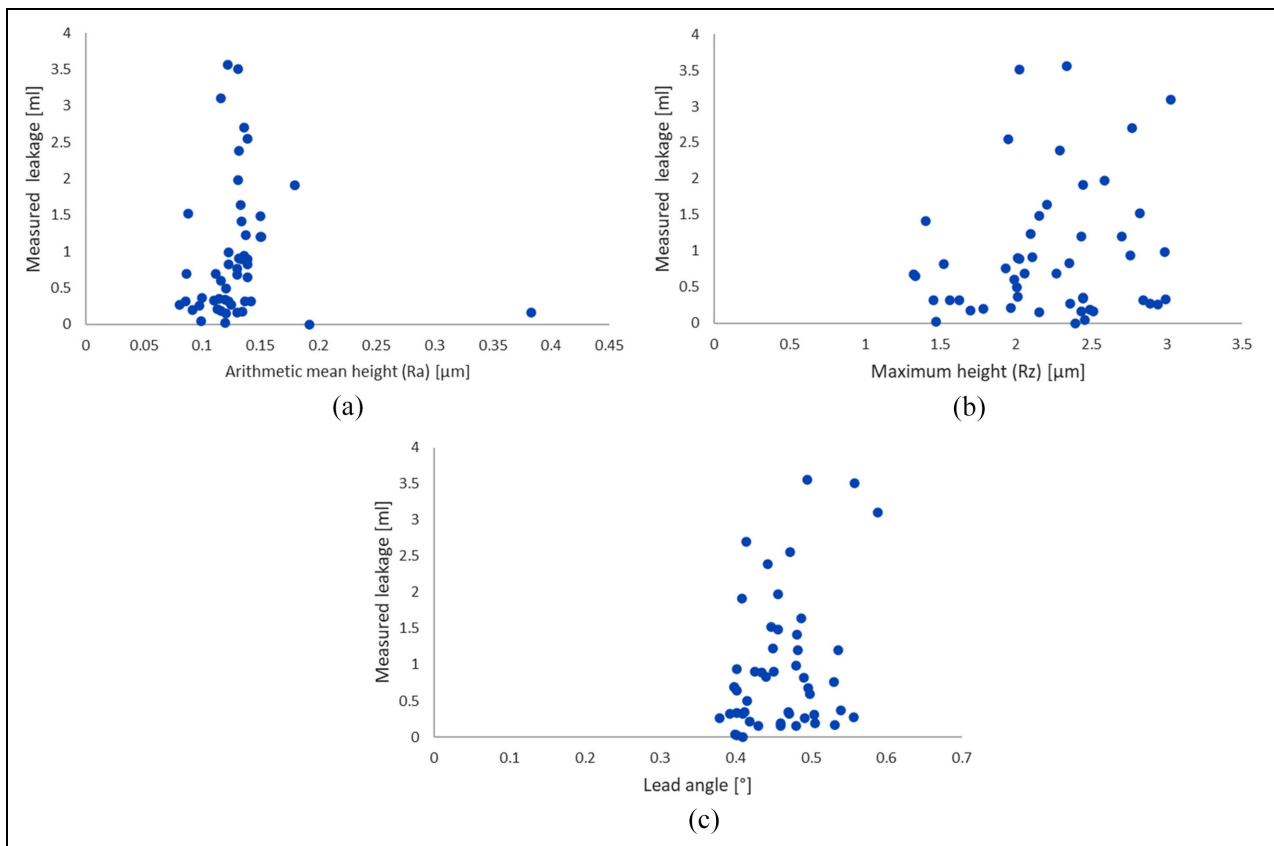
Based on the results for the corundum ground shafts, no specific quantitative correlation is found between the measured leakage and surface topographical parameters; Ra and Rz as well as with the lead angle, as can be seen from Figure 12(a) to (c). This can be further verified by determining the standard Pearson correlation coefficient for the presented measurements. A

correlation coefficient between the measured leakage and the Ra, Rz and lead angles are obtained as 0.016, 0.174 and 0.300, respectively, indicating existence of no or very weak correlations.

Figure 12. Measured leakage against (a) Ra, (b) Rz and (c) lead angle for corundum ground shafts.

The standards suggest acceptable lead angles in the range of 0° – 0.05° . As it can be seen from Figure 12(c), the lead angles for the corundum shafts exceed this range. Therefore, it is expected that the existence of such patterns can contribute to the observed leakage from those shafts. However, as it is clear from Figure 12(c), it is very difficult to establish a correlation

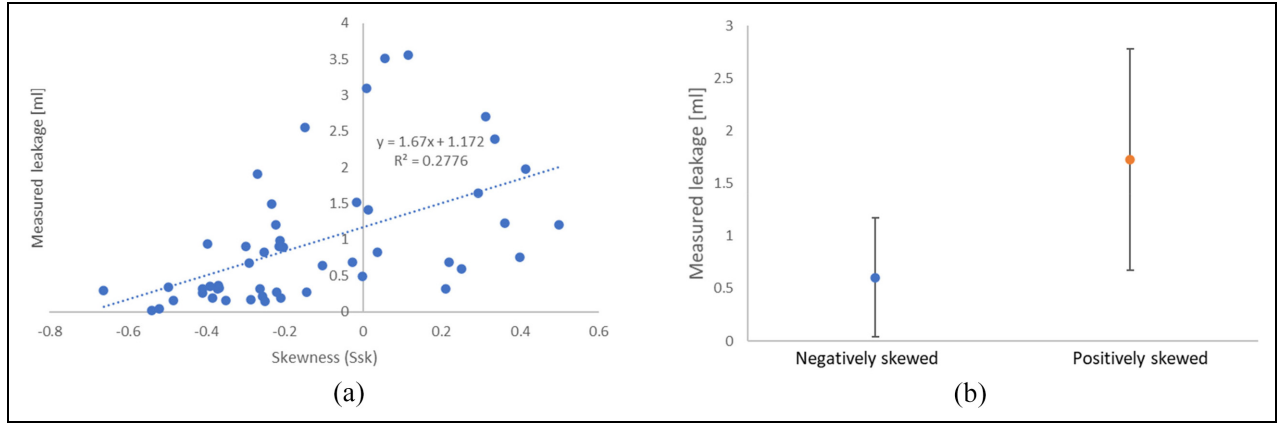
Figure 13. (a) Measured leakage variation with skewness for the corundum ground shafts and (b) average measured leakage for negatively and positively skewed shaft surface roughness.

The results for measured leakage against skewness are shown in Figure 13. Figure 13(a) shows that there is a trend in the presented data. The calculated Pearson correlation coefficient shows a value of 0.538, indicating the existence of a reasonable correlation between the measured leakage and the shaft skewness. There is a larger spread in the leakage for shafts with positive skewness value as can be seen in Figure 13(b). In addition, Figure 13(b) shows that the overall average leakage for negatively skewed shafts is lower than that for the positively skewed shafts. It also seems that the likelihood of leakage increases for negatively skewed shafts with a reduced skewness magnitude. This is evident by comparing the average measured leakage values for shafts with negative and positive topographical skewness as shown in Figure 13(b). Conducting a t -test for the data shown in Figure 13(b), results in a t -value of 4.92, which is greater than t -value of 2.02, based on typical 5% alpha confidence level for 48 degrees of freedom obtained from t -distribution table. Therefore, the null hypothesis that there is no difference between

the two average values shown in Figure 13(b) because of any standard deviation overlap can be rejected.

Therefore, the results in Figure 14 along with the leakage data shown in Figure 13 suggest that there is a good correlation between surface roughness skewness and lubricant leakage.

fit equation presented in Figure 13(a) describing the observed trends between the measured leakage and skewness of the corresponding shafts:

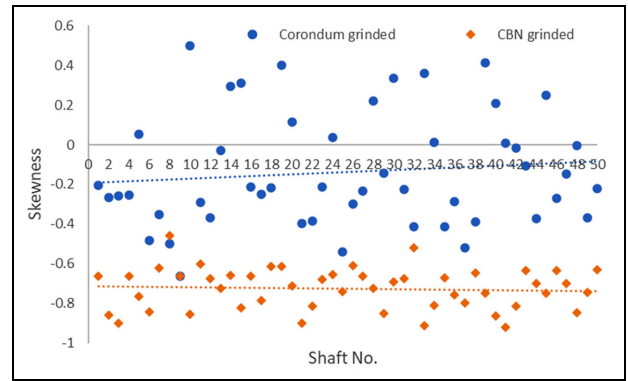
Figure 14. Measured skewness values for both corundum and CBN ground shafts.

The measured skewness of the corundum shafts is compared with those of their CBN counterparts, with the latter showing insignificant measurable leakage for the tests. The results for the measured skewness values are shown in Figure 14. As it can be observed, there is considerable difference between the measured skewness values for the CBN and corundum ground shafts. On average, based on the trend lines shown in the figure, the skewness values for the corundum ground shafts are more than fivefold smaller.

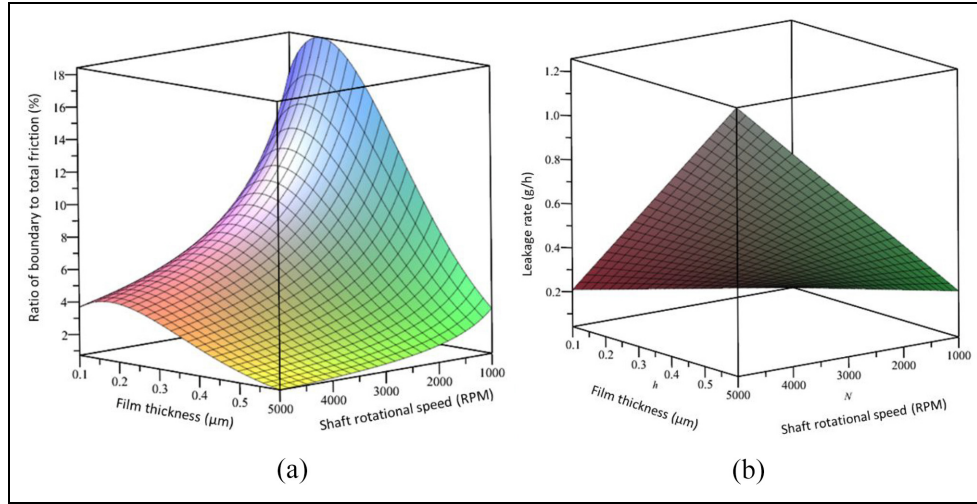
Figure 15. Predictions: (a) contributions from boundary friction and (b) leakage rate.

friction attains its maximum value. The value of this specific point depends on a number of parameters, but mainly on the shaft surface roughness. Existence of this peak is related to the difference in the rate at which the frictional torque due to viscous shear of the lubricant film and that of asperity interactions rise or fall with film thickness, based upon the equations used. For the studied cases here, the contributions from the boundary friction remain below 18% of the total and is expected to reduce further with increasing rotational speed. Figure 15(b), on the other hand, shows the predicted leakage mass flow rate for the same speed and film thickness range. These predictions show that if the rotational speed during the tests increases, the leakage rate would also increase accordingly irrespective of the size of the gap. However, the leakage would be higher for the shafts having a larger gap size.

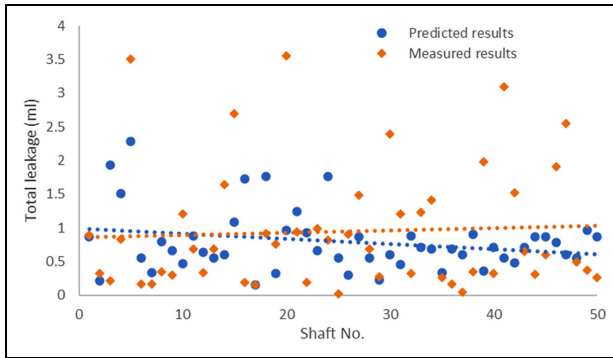
Figure 16 compares the predicted leakage using the analytical model with those directly measured. Considering the simplicity of the model used, it is noteworthy that reasonable order of magnitude agreement

Figure 16. Comparison of predicted and measured leakage values for all shafts.

exists between the predicted and measured data. The best fit trend lines in Figure 16, shown for both the data sets corroborate this despite the existence of individual differences between the predicted and measured leakages for each shaft. As expected, it is difficult to make a direct comparison between the individual points as the simple model used here does not take into account many details related to the topographies of the seal and the shaft. However, it is quite remarkable that the trend lines for both set of data correlate quite well.

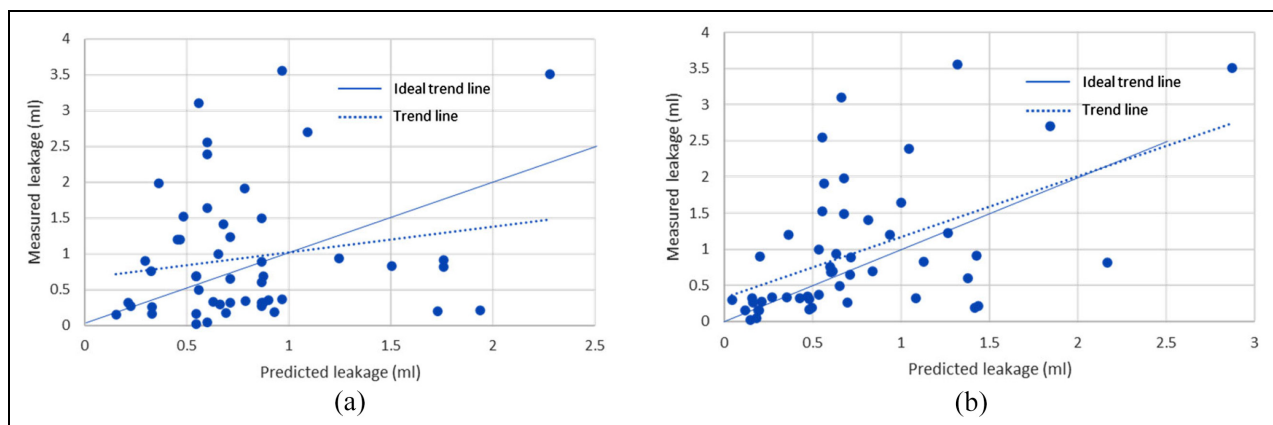
Figure 17. Measured leakage versus (a) predicted leakage and (b) scaled predicted leakage including shaft surface topographical skewness.
